Site Survey 1st February 2006

REPORT PREPARED FOR
Andrew Searle
Technical Services PTSD

STRUCTURAL INSPECTION
AT
TROOPERS HILL CHIMNEYS
Re-inspection

1st February 2006

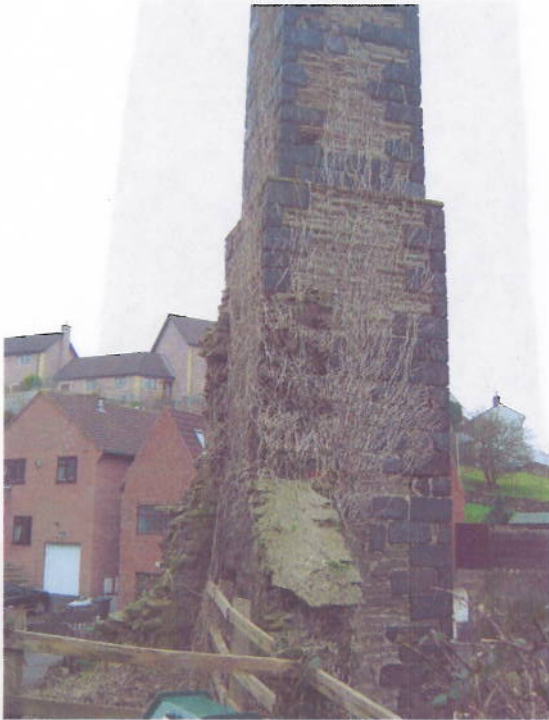
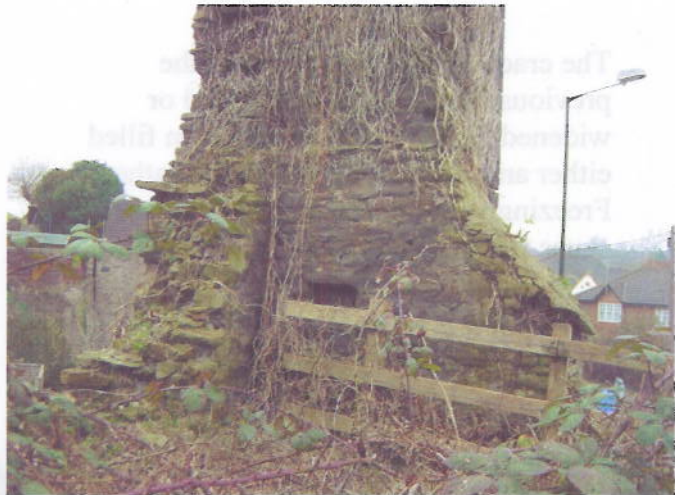
Lower Chimney

There is very little to report other than to reiterate the minor concerns contained in the 2004 reports.

No discernable deterioration was noted.

- The chimney is in reasonable condition and much of the growth that recently covered the structure has been cut back or killed. It is important that this is kept under control and annual maintenance is recommended.

- The ragged edges where presumably walls ran out from the chimney tower should be tidied up by rebuilding the ends. This will prevent stonework working loose over time and help prevent further deterioration.

- The top should be accessed and any loose material re-bedded or removed. This should be done immediately as there does appear to be a danger from falling masonry. From ground level it could not be seen if this recommendation had been carried out and so is repeated here. Loose stones falling from height would constitute a considerable danger to both pedestrians and motorists.

- In the next few years consideration should be given to repointing as this is beginning to deteriorate and could affect the long term stability of the chimney.

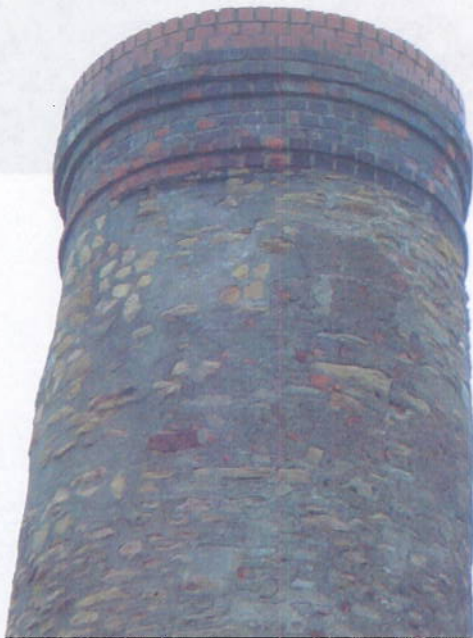
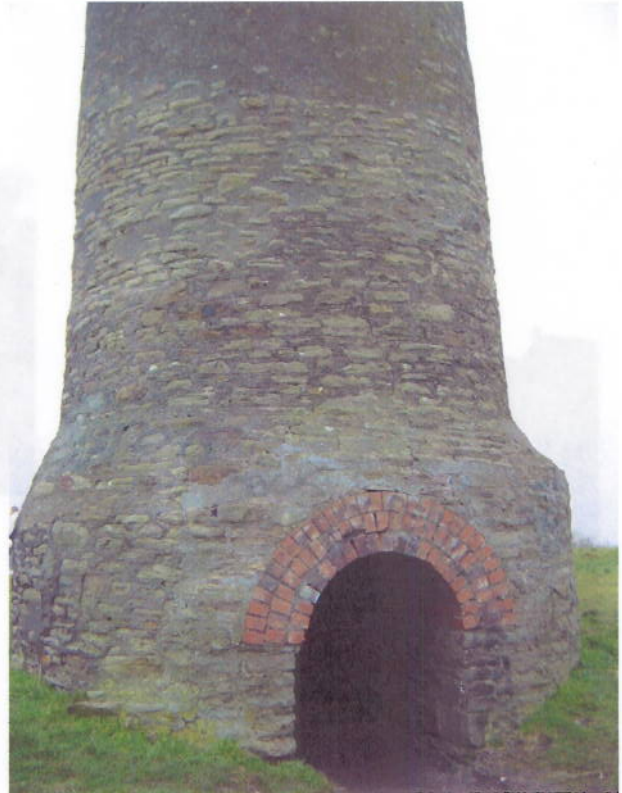
Upper Chimney

There is very little to report other than to reiterate the minor concerns contained in the 2004 reports.

No discernable deterioration was noted.

The crack on this face noted in the previous report has not extended or widened. However it has not been filled either and remains open to the weather. Freezing water in the crack is liable to cause further damage.

- It is recommended that a survey firm be appointed to measure movement of the top of the tower. It would also be useful to install studs either side of the vertical crack above the opening. These can then be measured to establish if the crack is widening or extending.
- Further visual surveys should be carried out at 12 monthly intervals
- Although there is no immediate cause for concern, consideration might be given to internal strengthening at some point in the future. This could be achieved by the introduction of steel hoops resin bolted to the inside of the chimney.
