REPORT PREPARED FOR
Adrian Frost
Technical Services DETL

STRUCTURAL INSPECTION
AT
TROOPERS HILL CHIMNEY

11th November 2004

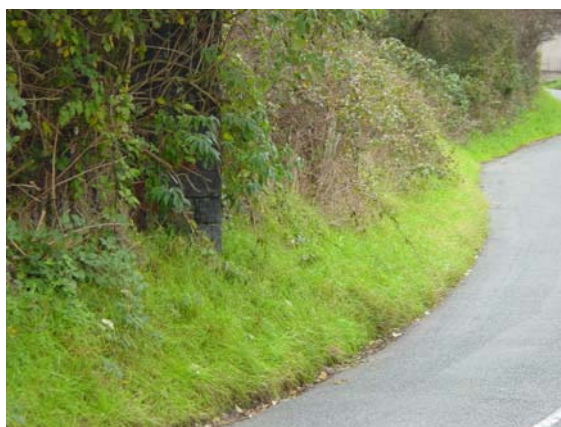
The chimney is sited at the bottom of Troopers Hill Road. Impact damage from vehicles is possible due to its close proximity to the road, however there is no sign of damage to date.

The chimney is predominantly constructed of local stone and appears to be in relatively good condition although close examination was prevented by growth on and around the structure. Most of the growth on the structure itself is dead but careful removal would allow a better assessment of its structural condition.

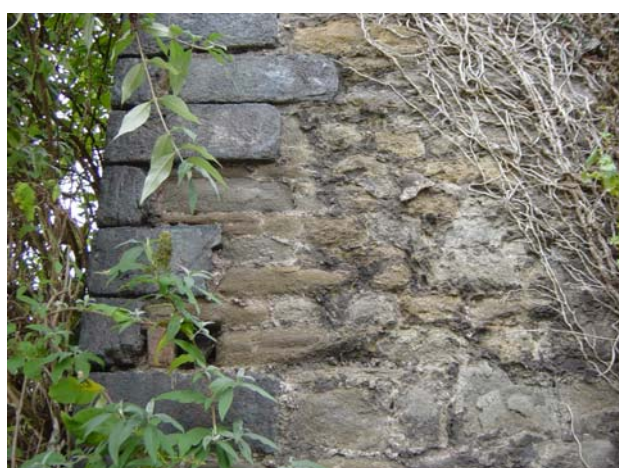
The top of the chimney has irregular stonework that may be loose. As any falling stones would present a danger to the public further investigation should be made and stones re-set or removed as necessary.

The top should be accessed and any loose material re-bedded or removed. This should be done immediately as there does appear to be a danger from falling masonry.
