Site Survey 1st February 2006

REPORT PREPARED FOR
Andrew Searle
Technical Services PTSD

STRUCTURAL INSPECTION
AT
TROOPERS HILL CHIMNEYS
Re-inspection

1st February 2006

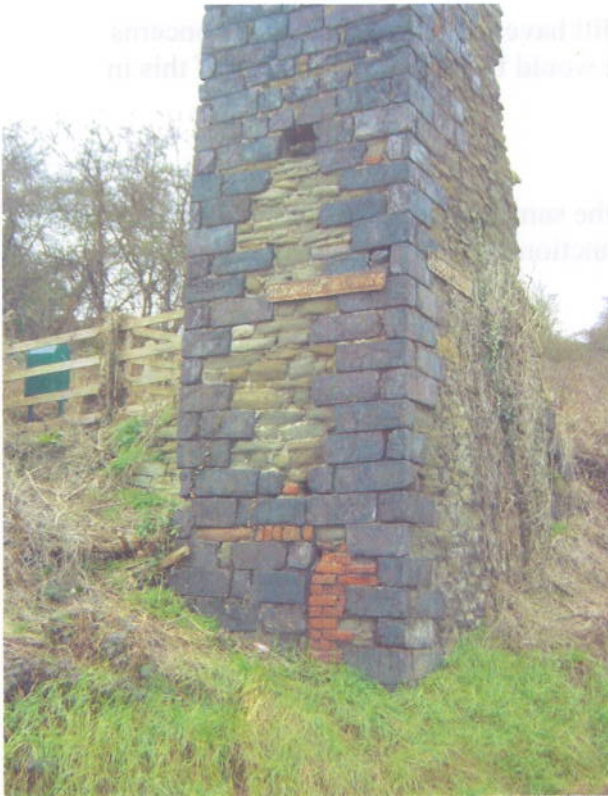
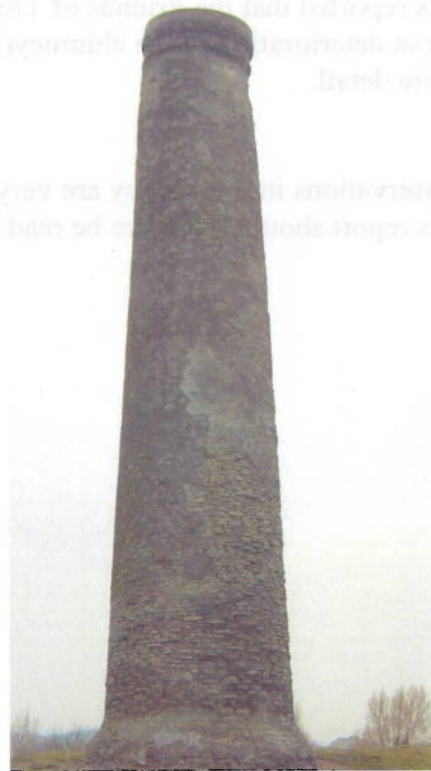
The crack on this face noted in the previous report has not extended or widened. However it has not been filled either and remains open to the weather. Freezing water in the crack is liable to cause further damage.

- It is recommended that a survey firm be appointed to measure movement of the top of the tower. It would also be useful to install studs either side of the vertical crack above the opening. These can then be measured to establish if the crack is widening or extending.
- Further visual surveys should be carried out at 12 monthly intervals
- Although there is no immediate cause for concern, consideration might be given to internal strengthening at some point in the future. This could be achieved by the introduction of steel hoops resin bolted to the inside of the chimney.
